# Capacitive Micro machined Ultrasonic Transducers arrays (CMUTs) for Structural Health Monitoring (SHM).

Journée nationale contrôle sante et monitoring des structures March 12, 2020, Paris, France

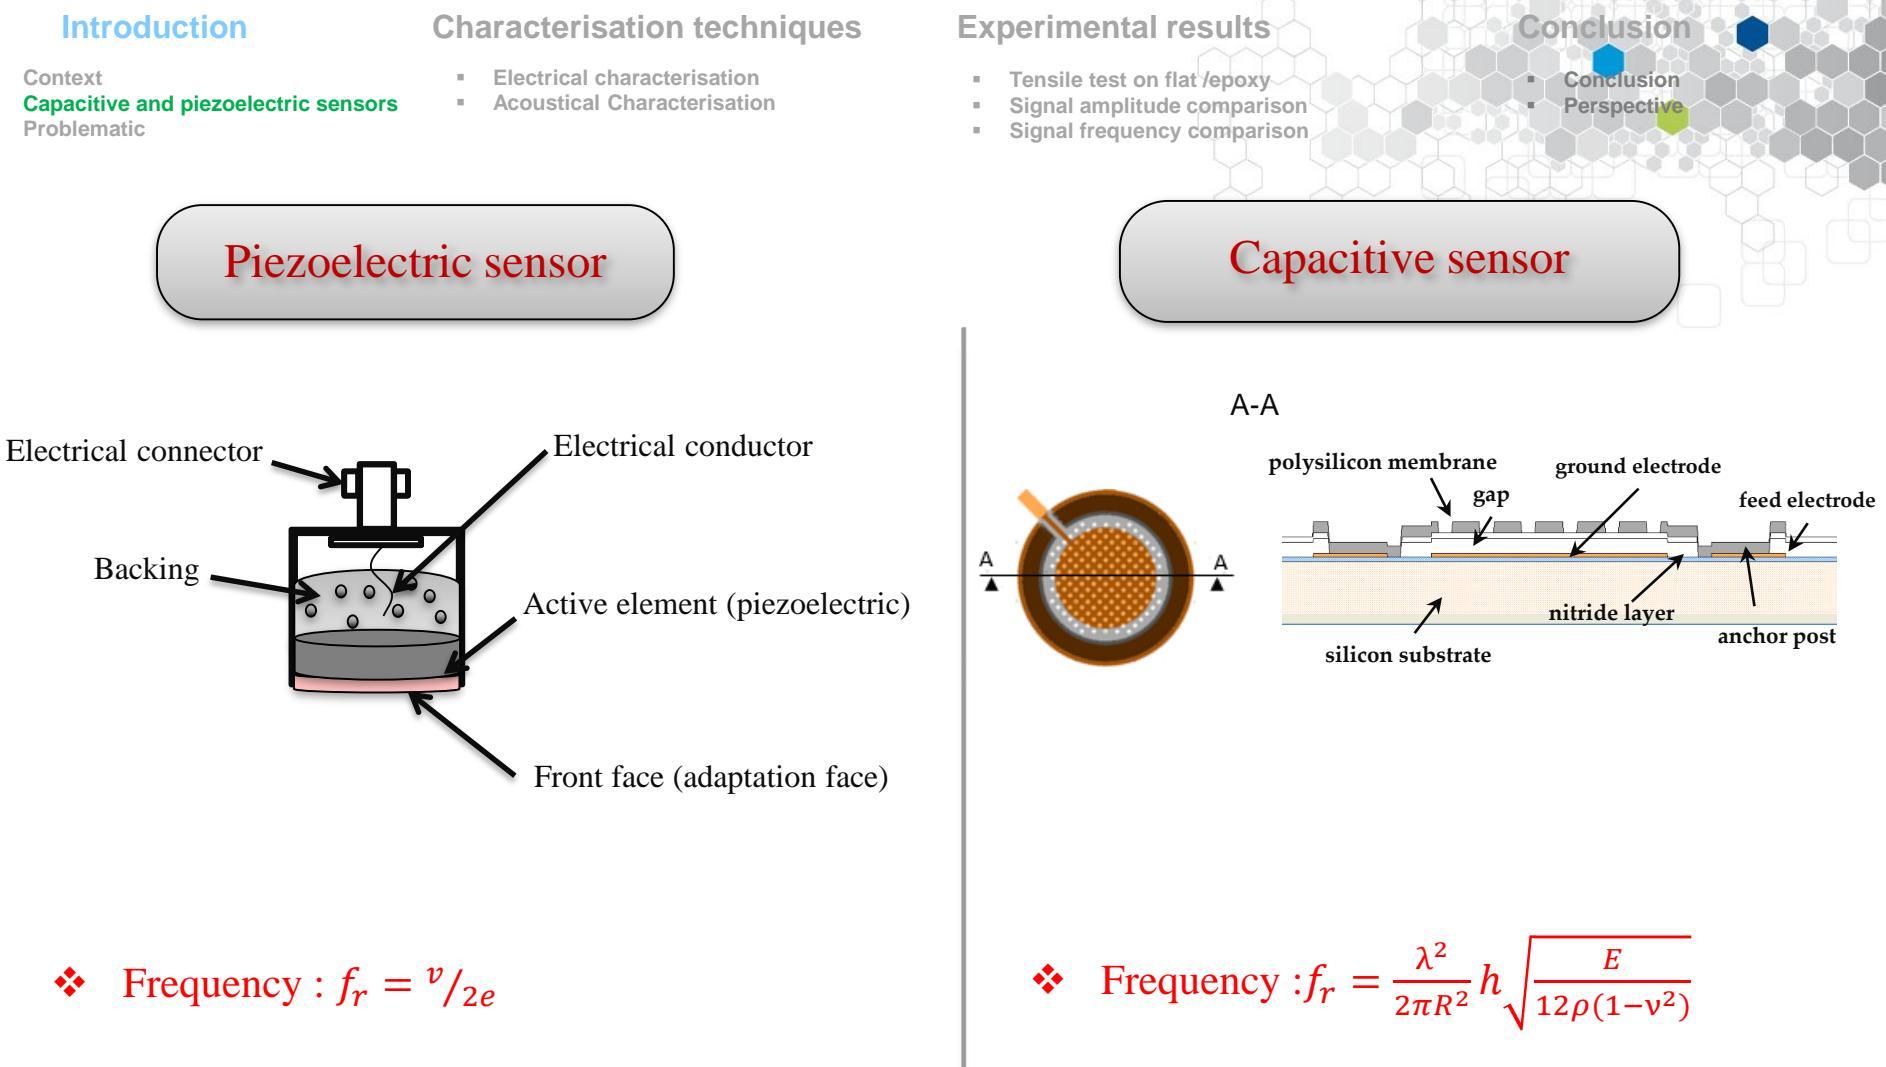
Size: 10 mm diameter X 12 mm height

Size: 16 mm diameter X 1.6 mm height

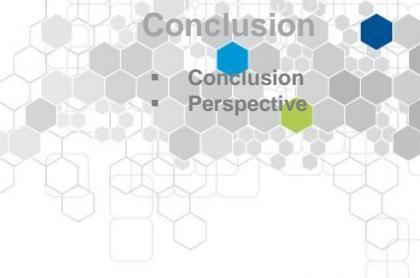
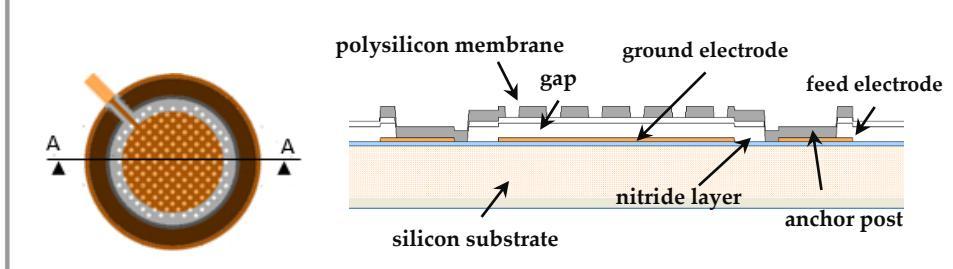
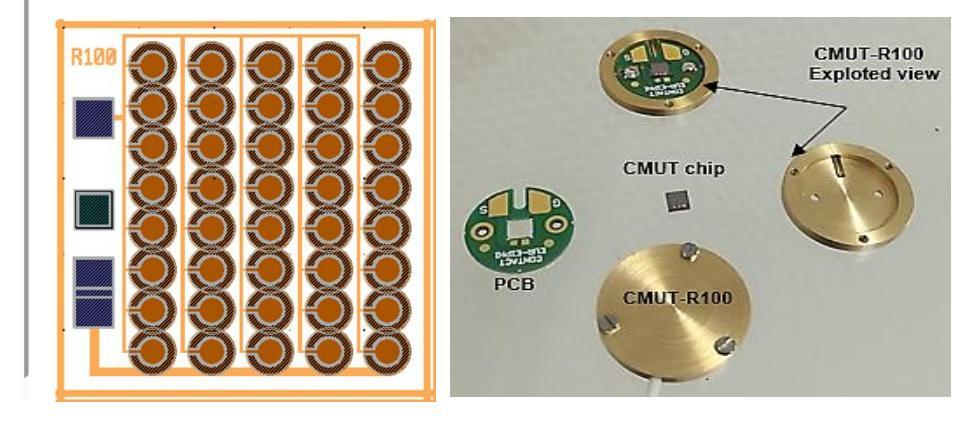
- Capacitive Micro machined Ultrasonic Transducer (CMUT):
  - 2.5 mm X 2.5 mm chip
  - 40 elementary cells
  - PCB 12 mm diameter for electrical contact
  - Wire bonded
  - Encapsulated on 16 mm diameter

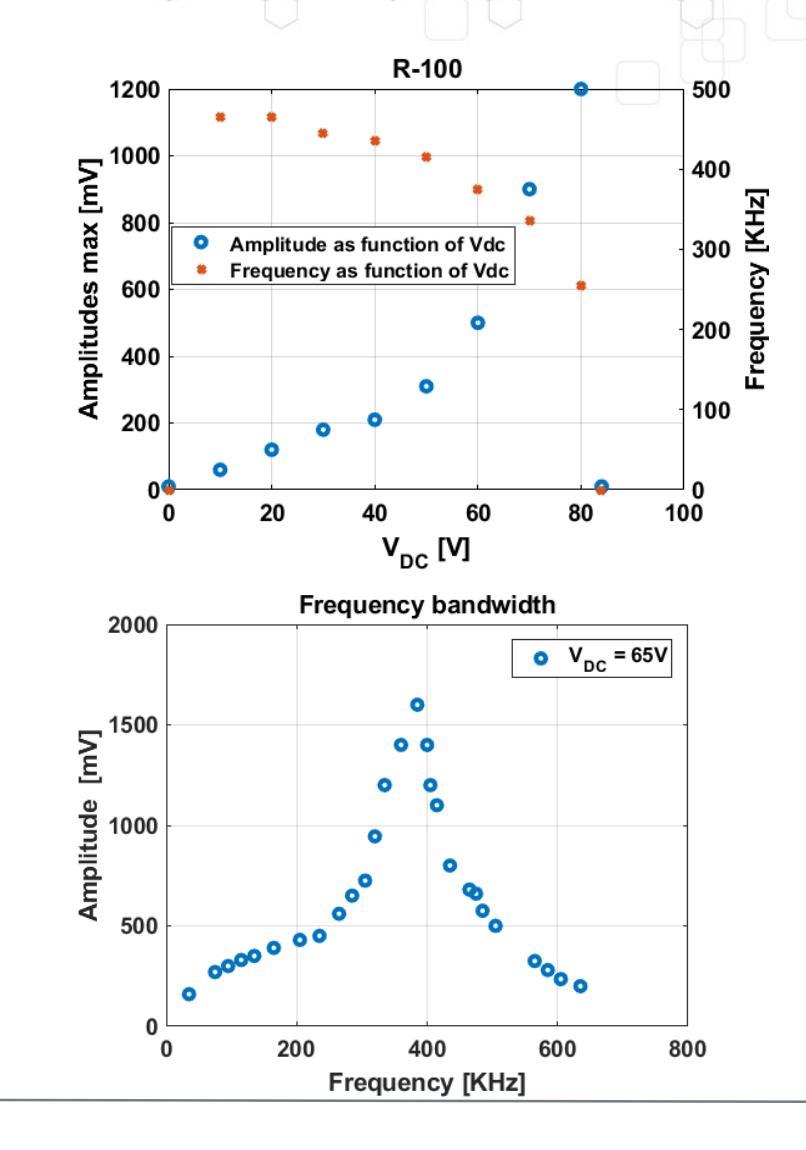
- Bias voltage is adjusted between 0V to collapse voltage
- We applied V<sub>AC</sub>=0.5V peak-to peak with a synthesizer function generator (Helwett Packard 3325 B
- We measured the maximum amplitude of CMUT-R100 with laser Polytec vibrometer
- ✤ Collapse voltage at 85 V
- ✤ We applied 80% of collapse voltage
- Bandwidth frequency between 300 KHz to 500 KHz

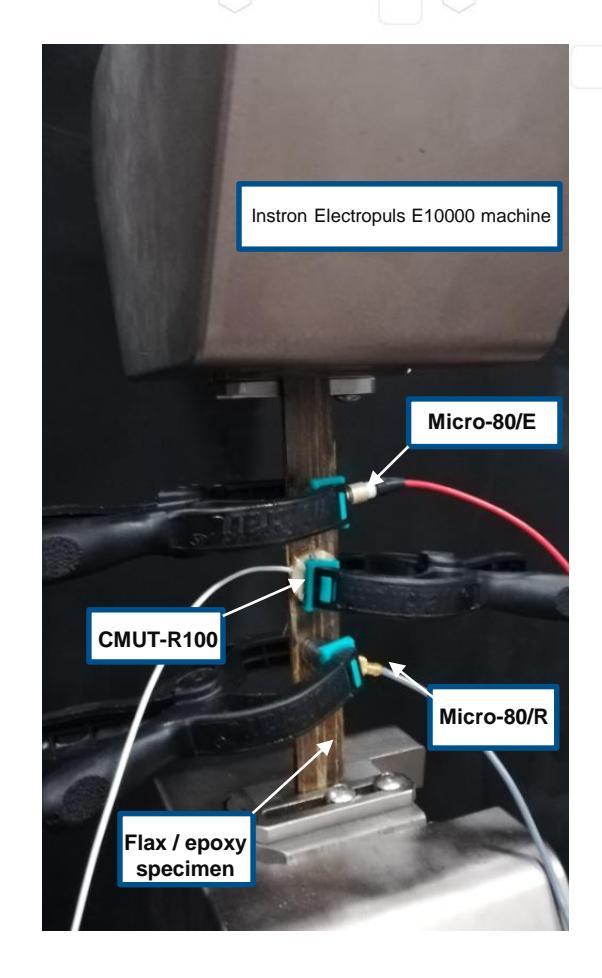
- ✤ MTS Criterion machine equipped with 100 kN
- ✤ Load sensor control 0,1 mm/s axial
- ✤ 3 sensors are placed on flax /epoxy plate
- Streaming data of AE signal was recorded during 50 seconds

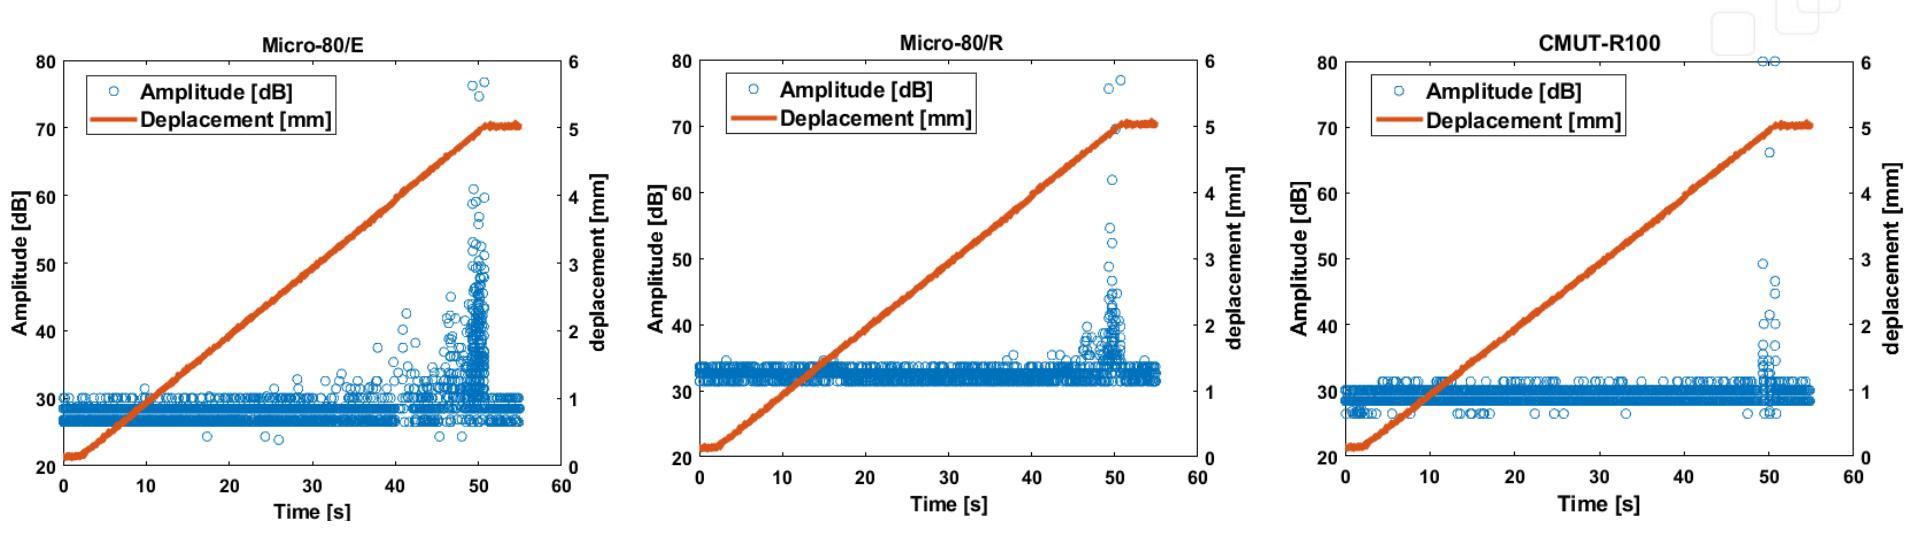
- CMUT-R100 depicts an important AE activity compared with Micro-80/R
- ♦ At the end of tensile test, three transducers have the same amplitude of AE activity (80 dB)

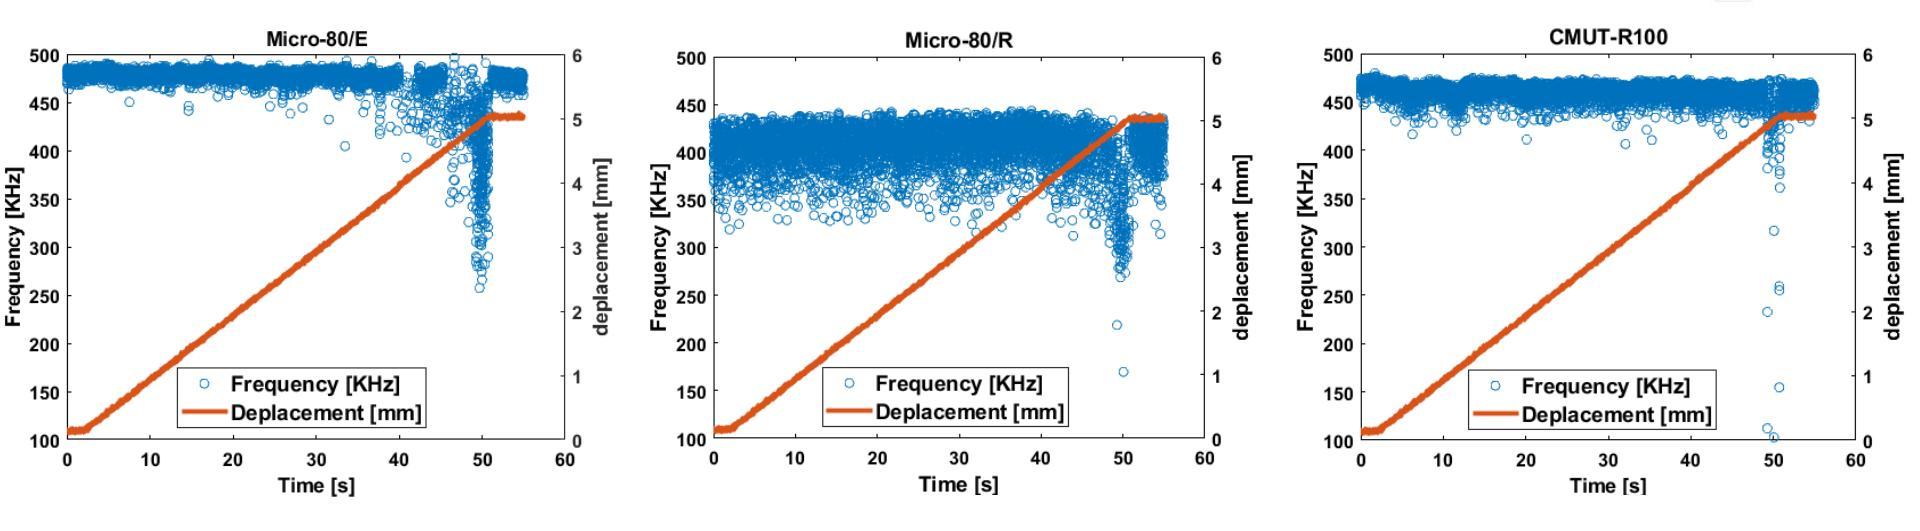
- ✤ CMUT-R100 shows an important AE frequency activity
- $\clubsuit$  The shape response of the three transducers is similar
- At the end of tensile test, the frequency response of CMUT-R100 is comparable to μ80 E and R

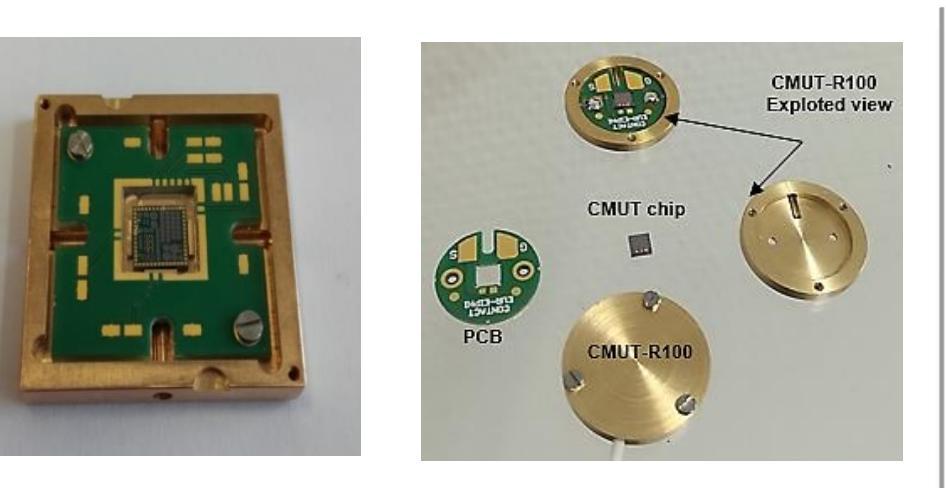
- ✤ Miniaturisation of the capacitive transducer
  - Volume CMUT-V1: 2304 mm<sup>3</sup>
  - Volume CMUT-R100: 322 mm<sup>3</sup>

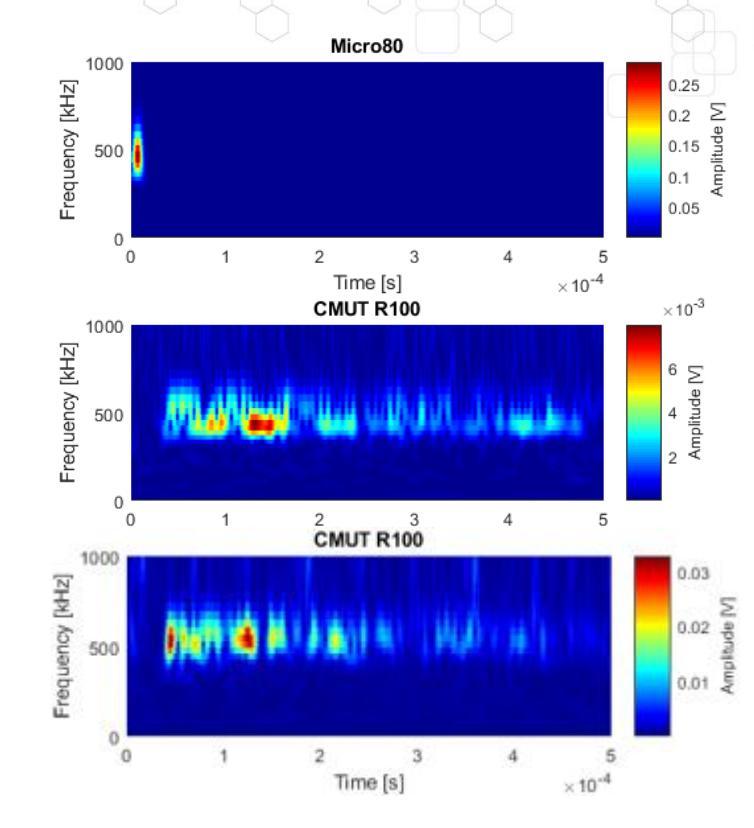
- ✤ Improvement of the detected signal
  - Amplitude CMUT-V1: 7 mV
  - Amplitude CMUT-R100: 30 mV

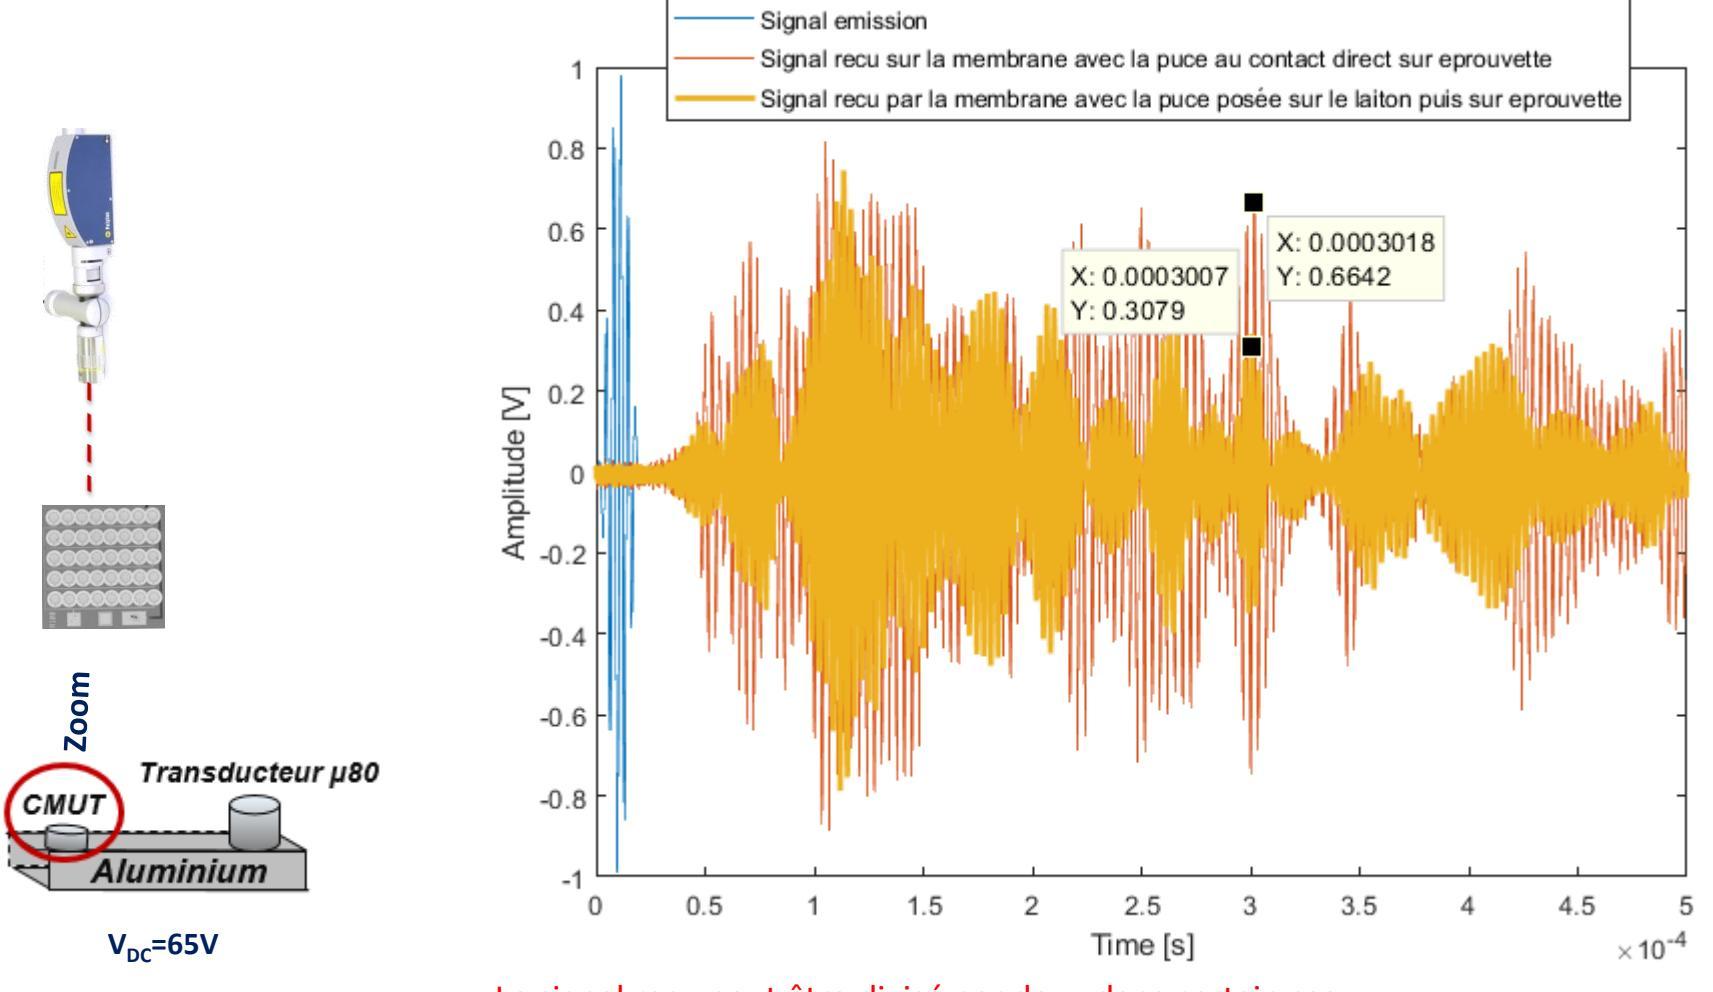
### <sup>2</sup>Travaux 2019-2020 : Etude de la réponse acoustique d'une membrane en fonction du couplage

Le signal reçu peut être divisé par deux dans certain cas

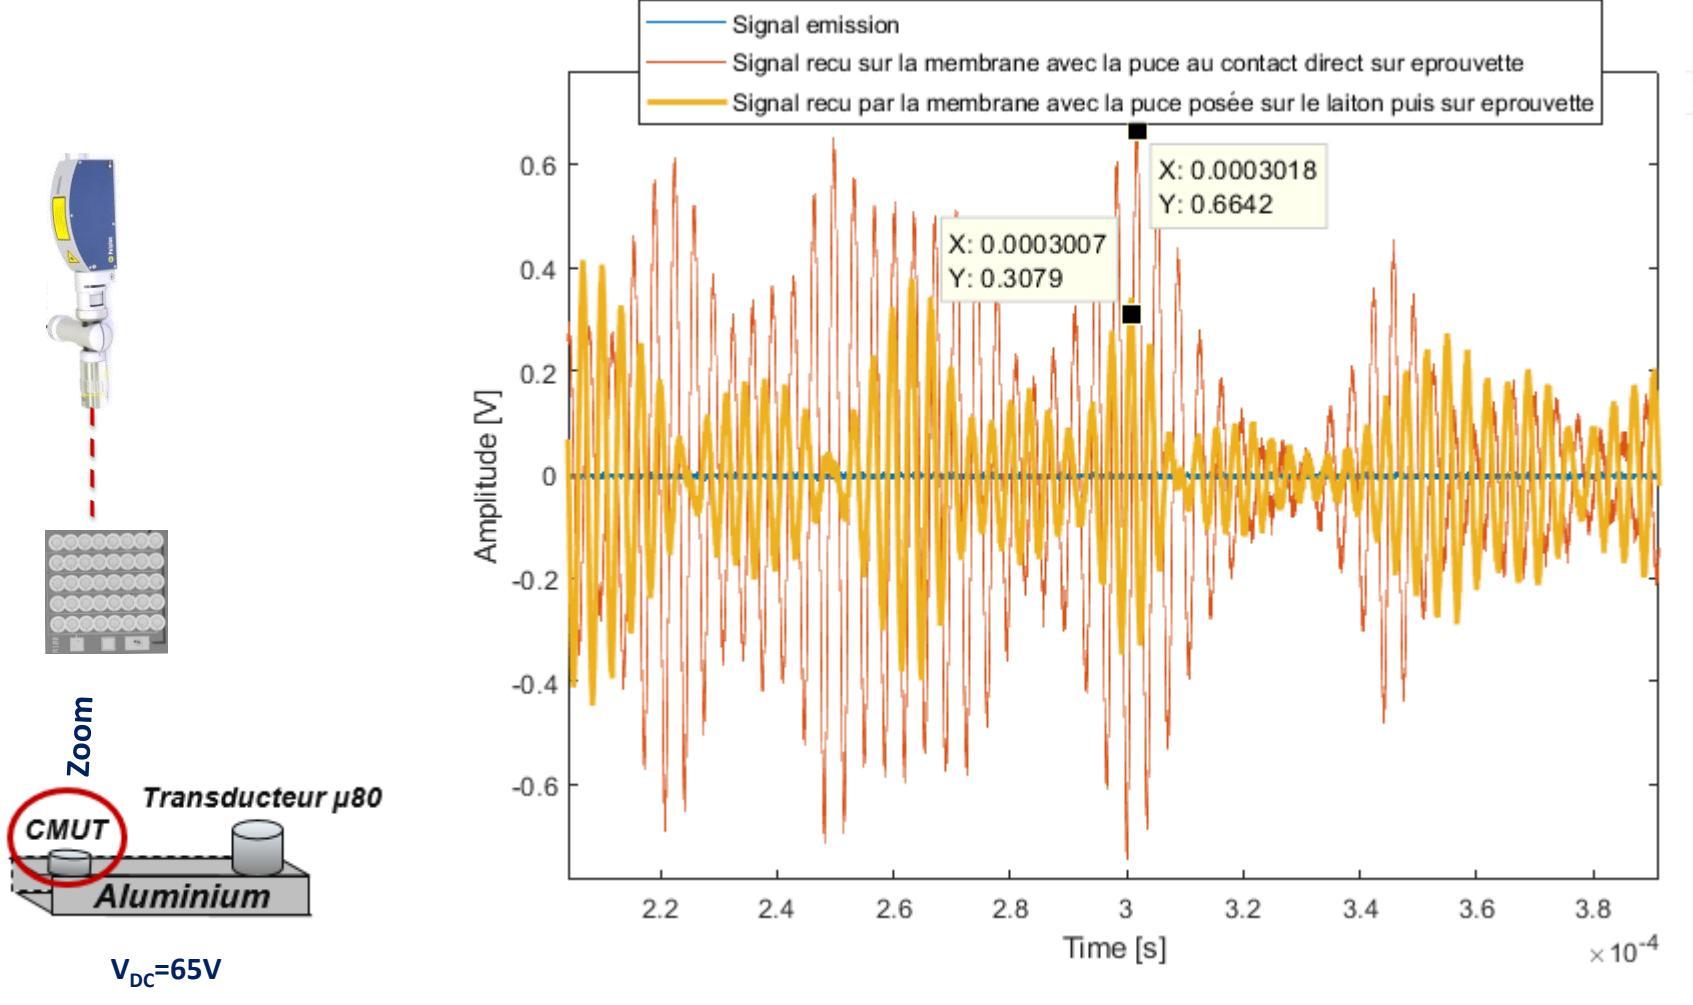
## <sup>2</sup>Travaux 2019-2020 : Etude de la réponse acoustique d'une membrane en fonction du couplage

Le signal reçu peut être divisé par deux dans certain cas
